National Dam Inspection Program. Still
Creek Dam (National I.D. Number PA-00700),
Schuylkill River Basin, Still Creek,
Schuylkill County, Pennsylvania. Phase I
Inspection Report,

STILL CREEK DAM
SCHUYLKILL COUNTY, PENNSYLVANIA
NATIONAL I.D. NO. PA 00700

PHASE I INSPECTION REPORT
NATIONAL DAM INSPECTION PROGRAM

June 1978

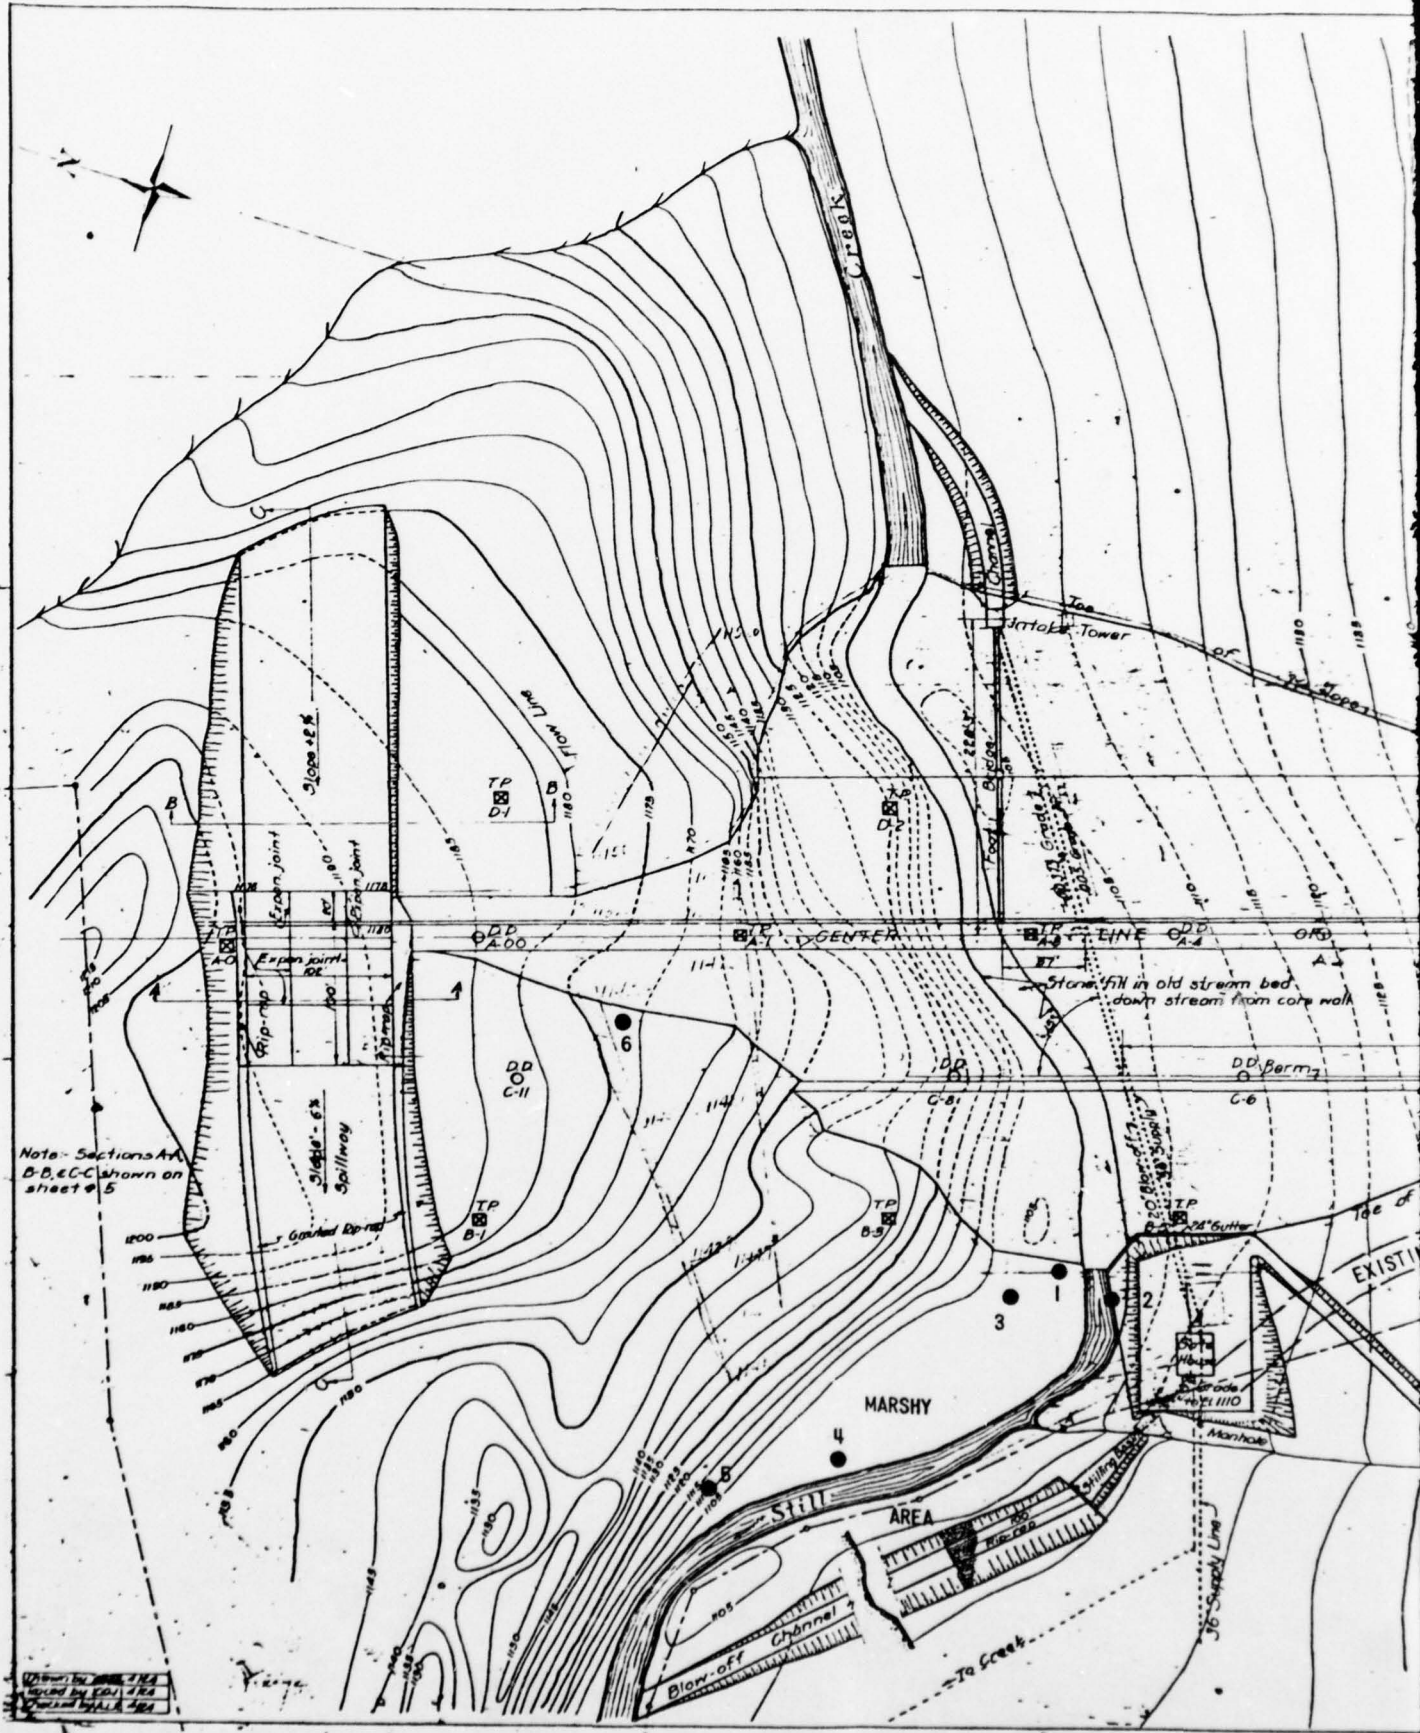
The observed water seeps are predominantly located within 100 to 200 feet of the dam crest (Sheet 5b). A lightly wooded area of overall marshy consistency (original Still Creek channel) is located just downstream from the toe of the dam and below the treatment building. This area (Location 1) is approximately 10 by 35 feet with water depths of up to 1 to 2 inches. No water flowage was observed in the upstream portion of this area. The water is a rust-brown color and was slightly odoriferous (hydrogen sulfide odor). Approximately 30 feet downstream from this marshy area (Location 2) water depths increase to 3 to 4 inches with visible minor flowage. On the northeast side of the pooled water is an irregular ground opening approximately $1/4$ to $1/2$ inch in diameter emitting a clear, turbulent flow of water at several gpm (unable to take accurate measurements). In this area the hydrogen sulfide odor was readily noticeable. The flowage of water then continues to the west where it joins water being discharged from behind the south wall of a weir behind the treatment building.

Progressing up the terraced slope near the northwest abutment just at the riprap margin (Location 6) an area approximately 5 by 30 feet (old spillway location) with 1 to 2 inches of standing, clear water was observed. This is the only pooled water observed above the toe of the dam in the abutment areas.

Several seepage areas were observed in the southeast abutment area. One is (Location 7) located in the woods adjacent to the dirt access road. Two additional water seeps (possible springs) were observed on both sides of a pipeline (Locations 8 and 9) where it crosses the paved road which leads to Route 309.

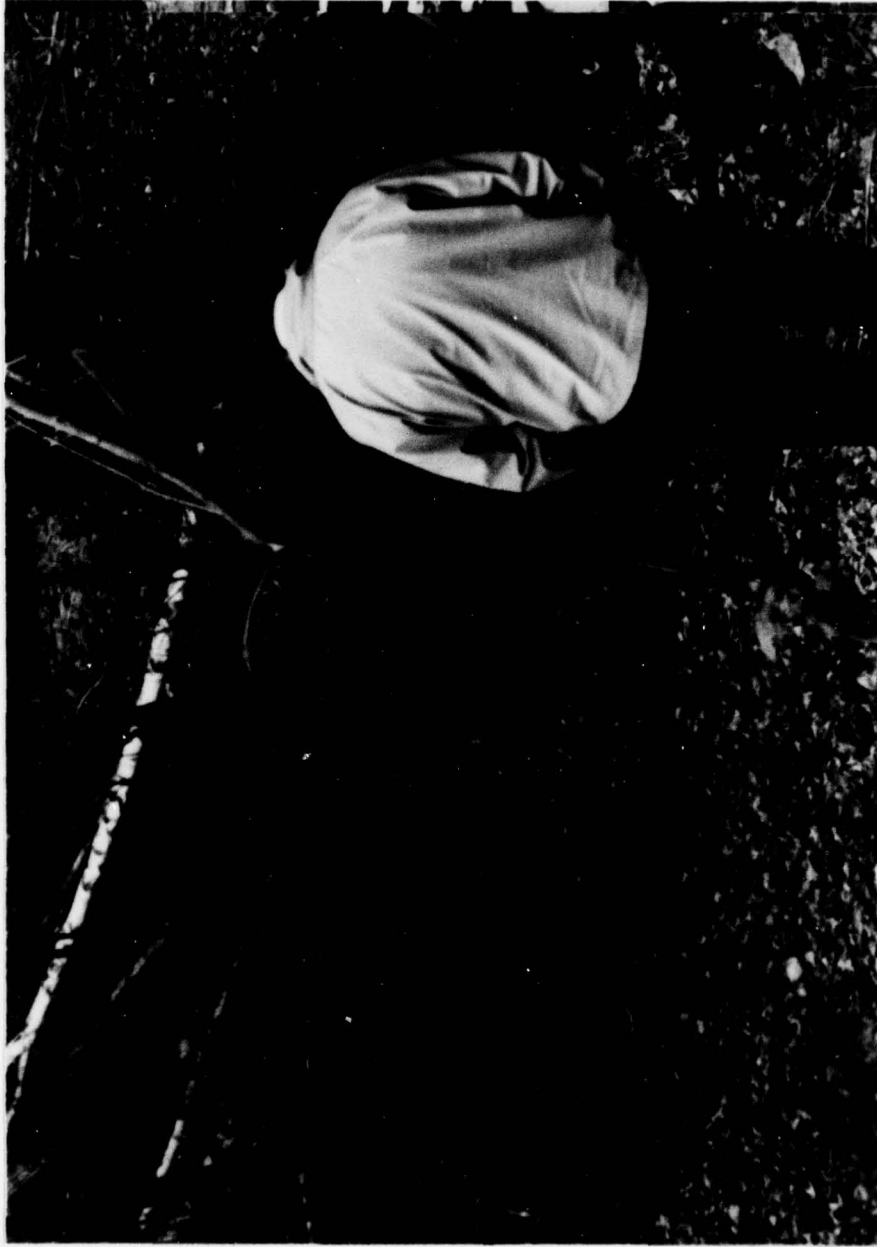
PHOTO NO. 7

a. Visual Observations. The visual observations did not indicate any existing embankment stability problems. Small seeps were observed however, at several locations downstream and near the toe of the dam. The clarity of the seepage water indicates that piping or erosion within the dam is not occurring. However, the lack of records of past seepage observations give no basis for judging whether changes have or have not occurred. A detailed discussion is enclosed in Appendix B on Pages 5a and 5b.

TYPICAL SEEPAGE ZONE. THIS PARTICULAR ZONE IS LOCATED
APPROXIMATELY 50 FEET DOWNSTREAM OF THE DAM TOE AND 150
FEET RIGHT OF CENTER. SEEPAGE EMERGES IN THE UPPER LEFT
SIDE OF PHOTO NEAR FALLEN TREE.

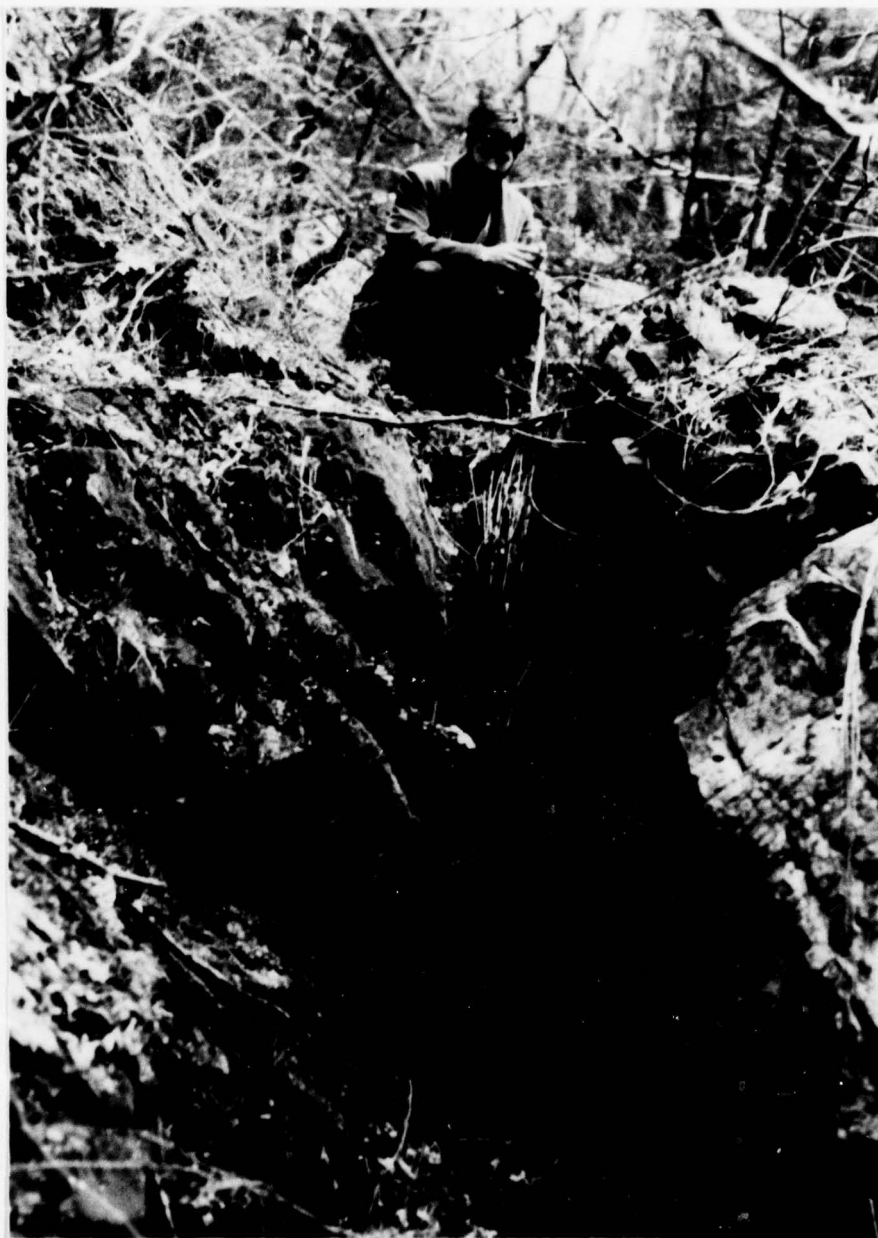
Factors which may be conducive for water seepage in the Still Creek Reservoir area include the north-northeast strike and south-southeast dip of the bedrock, the northeast strike and low angle dip of one set of bedrock joints. Also, the general thin-bedded nature of the rock would contribute to water seepages.

SOME SEEPAGE EMERGES THROUGH THE JOINTED
ROCK DOWNSTREAM OF THE DAM. THIS PHOTO
WAS TAKEN ON THE SOUTH DIPPING LIMB OF THE
DELANO ANTICLINE OUTCROP OF THE MAUCH CHUNK
SANDSTONE.

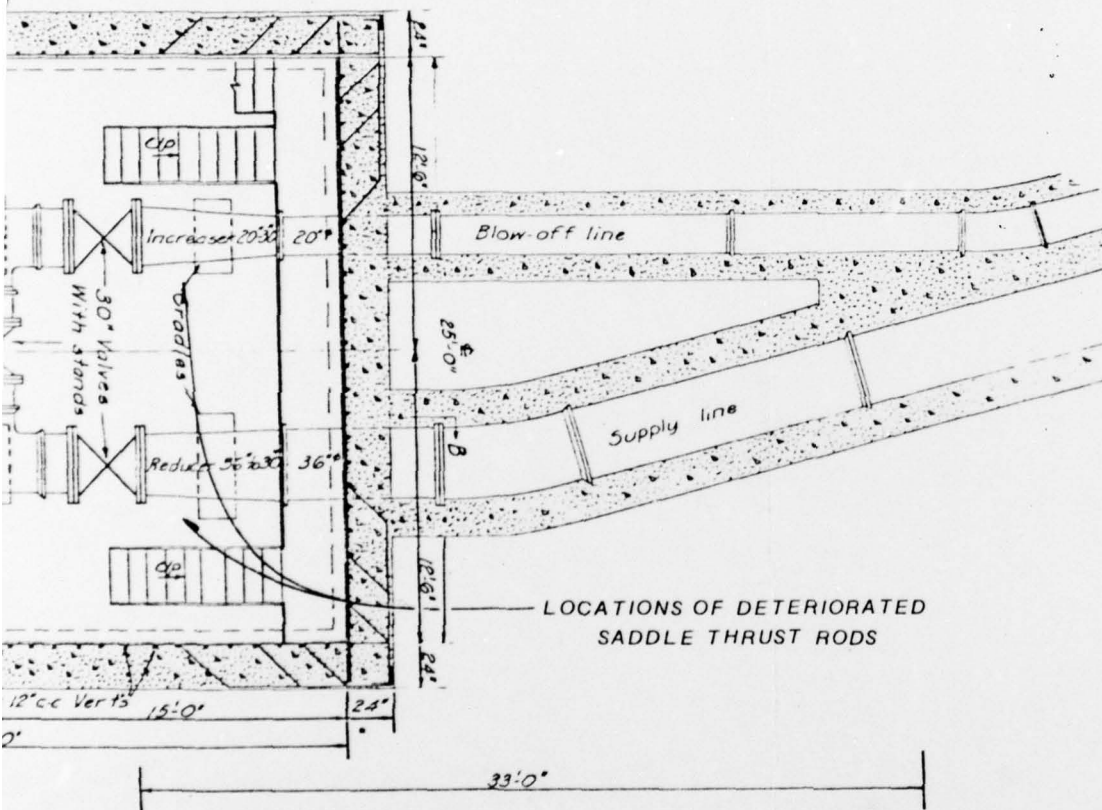
PUMPHOUSE FLOOR PLAN STILL CREEK DAM

VISUAL EXAMINATION OF	OBSERVATIONS	REMARKS OR RECOMMENDATIONS
CRACKING AND SPALLING OF CONCRETE SURFACES IN OUTLET CONDUIT	The conduit was buried and could not be inspected except for the end portion in the downstream pumphouse. This small section of pipe was in good condition.	
INTAKE STRUCTURE	Intake Structure (tower) was in good to excellent condition for its age. There were no significant cracks or deterioration. All intake valves were exercised and appeared to be in good condition. The Operator said that the sluice gates and other underwater components were refurbished in the Fall of 1976. The blow-off valve used for emergency drawdown is reportedly exercised once a year.	
OUTLET STRUCTURE	All valves in the outlet structure were inspected, exercised and found to be in good condition. All components within the structures were inspected and observed to be in good condition except the thrust rods for the intake pipe. The anchor bolts and hold-down flanges for these rods were deteriorated and are not capable of anchoring the intake pipes. These anchor rods should be replaced. The pumphouse building was inspected and appeared to be in good condition except the chimney and bearing plate on the chimney for the roof frame. It appears that the chimney cracked several years ago and was reinforced with channel steel and straps. The steel has deteriorated and buckled allowing the chimney to crack further. The chimney should be repaired.

LOCATION OF CHIMNEY
DISTRESS

5. The structural integrity of the chimney is questionable considering that the steel used to repair it several years ago has deteriorated and buckled. The chimney should be repaired.
